NASA/TM-2016-218978

Ultrasonic Nondestructive Evaluation of Pultruded Rod Stitched Efficient Unitized Structure (PRSEUS) During Large-Scale Load Testing and Rod Push-Out Testing

*Patrick H. Johnston and Peter D. Juarez
Langley Research Center, Hampton, Virginia 23681*

May 2016

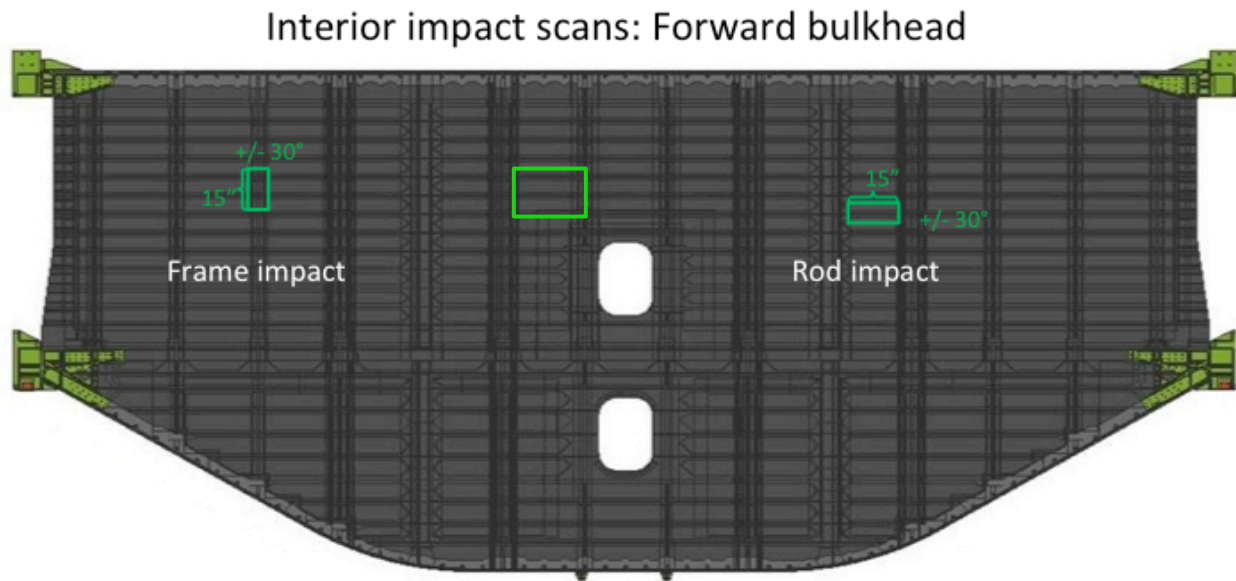
Three additional impacts were located on the forward bulkhead, with impact performed from the inside of the structure. Interior impacts were located as shown in Fig. 17. One interior impact was to the top of a stringer rod. A second impact was positioned on the curved top of a frame. The final impact site was on the skin at the center of a bay between two stringers and two frames.

FIGURE 17 Locations of the three forward bulkhead impact sites. These impacts were performed from the inside of the test article. A mid-bay impact was performed just above and to the left of the upper manhole.

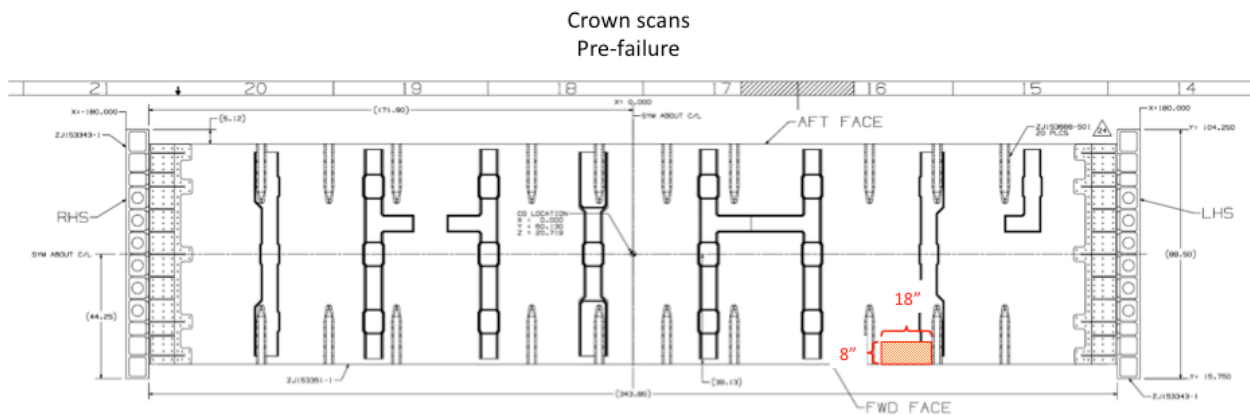
During the Pressure Cube Test, evidence of Type C delaminations (Fig. 8) was first detected in the interior fillet of the crown end caps during a 2P test. In anticipation that conditions for such delaminations could be produced during the MBB testing, a site was selected for nondestructive monitoring. Figure 18 shows the location on the crown of the site chosen.

FIGURE 18. Location of the Crown inspection site identified after the Phase III -1.0G load case.

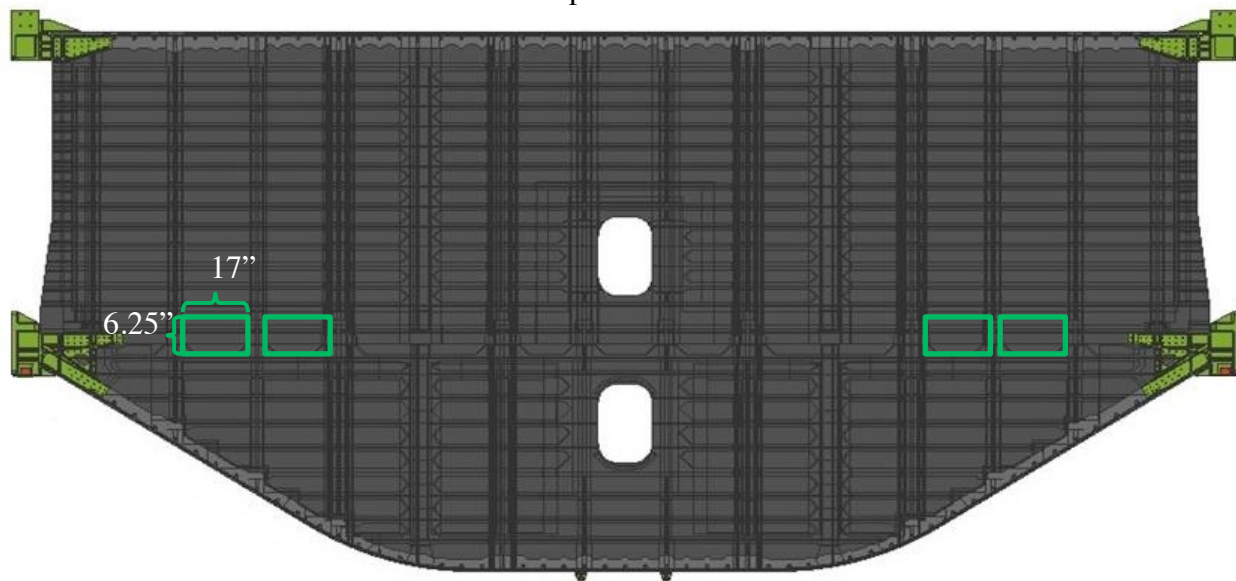
FIGURE 19. Locations of the four forward bulkhead sites identified for inspection following Phase III DUL. Four corresponding sites were also identified on the aft bulkhead.

During the MBB Phase III test, anomolous strain readings near the floor of the upper bay led to identification of eight areas for inspection, symmetrically located on the forward and aft bulkheads. These areas are indicated in Fig. 19.

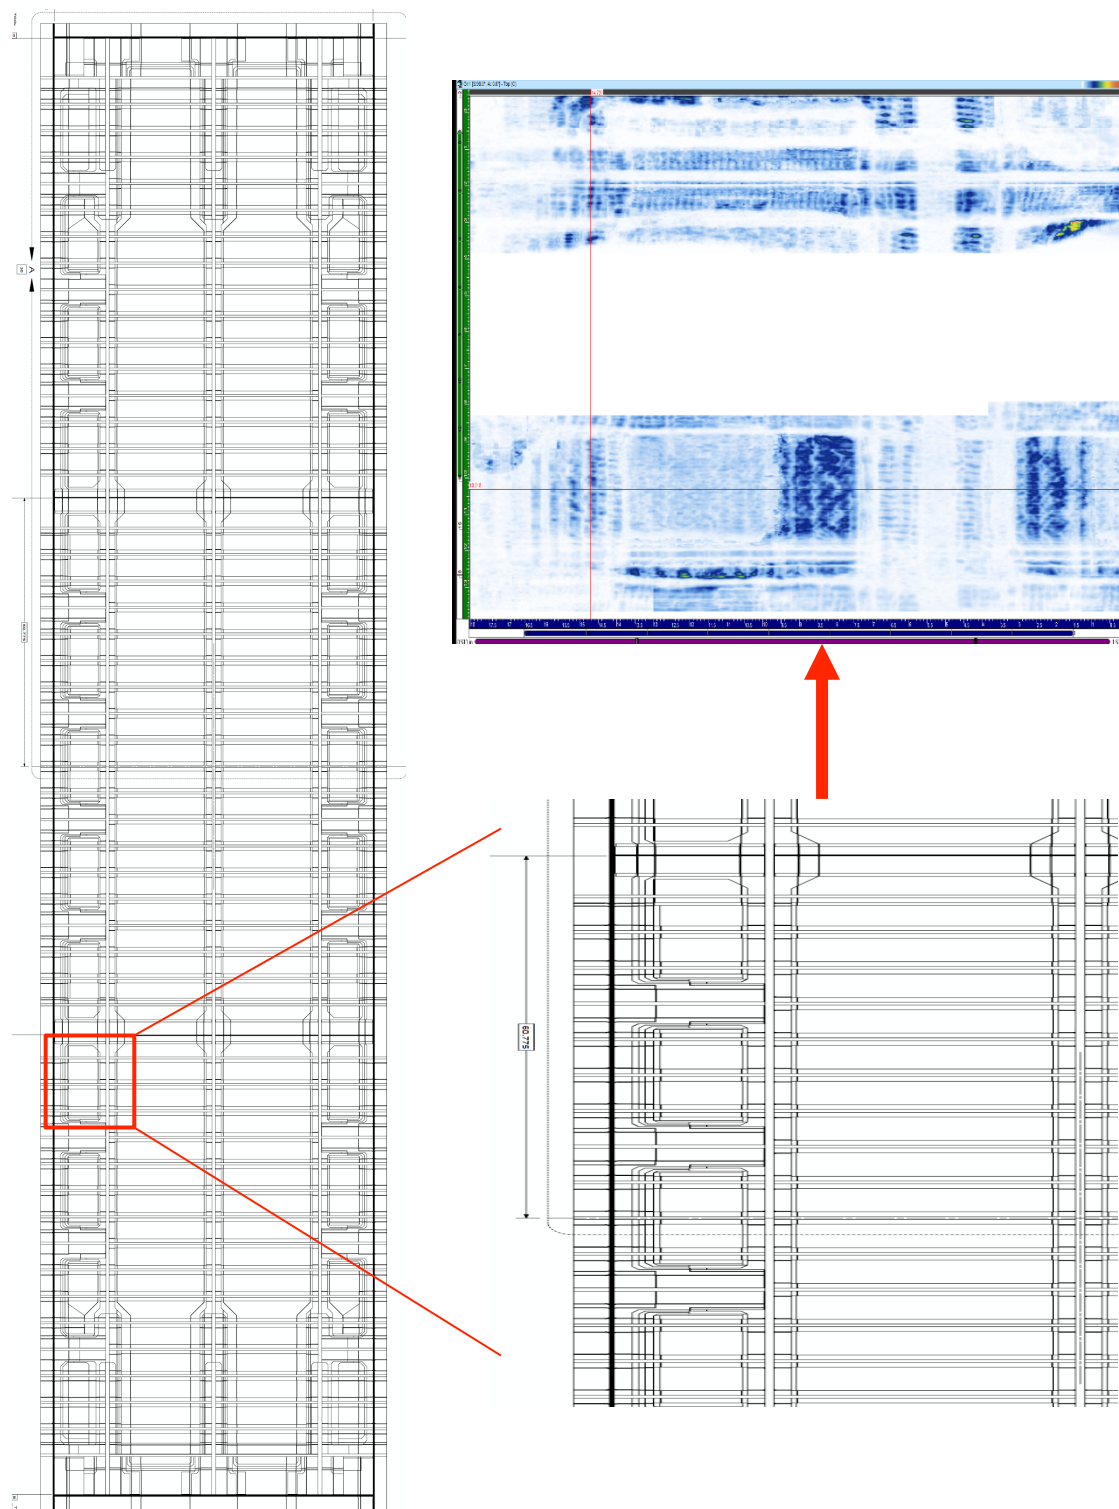
FIGURE 34. The location of the aft edge scan of the starboard failure crack.

Figure 34 indicates the location of the ultrasonic scan performed around the buckling crack on the aft starboard side of the crown, near the right center rib. Visual inspection of the interior of the MBB showed failures of the center frame and the aft tee cap at their intersections with stringer S9RC, and failure of the aft frame at its intersection with stringer S8RC. These were connected by a skin buckling crack which continued past the failed tee cap into the aft bulkhead panel.

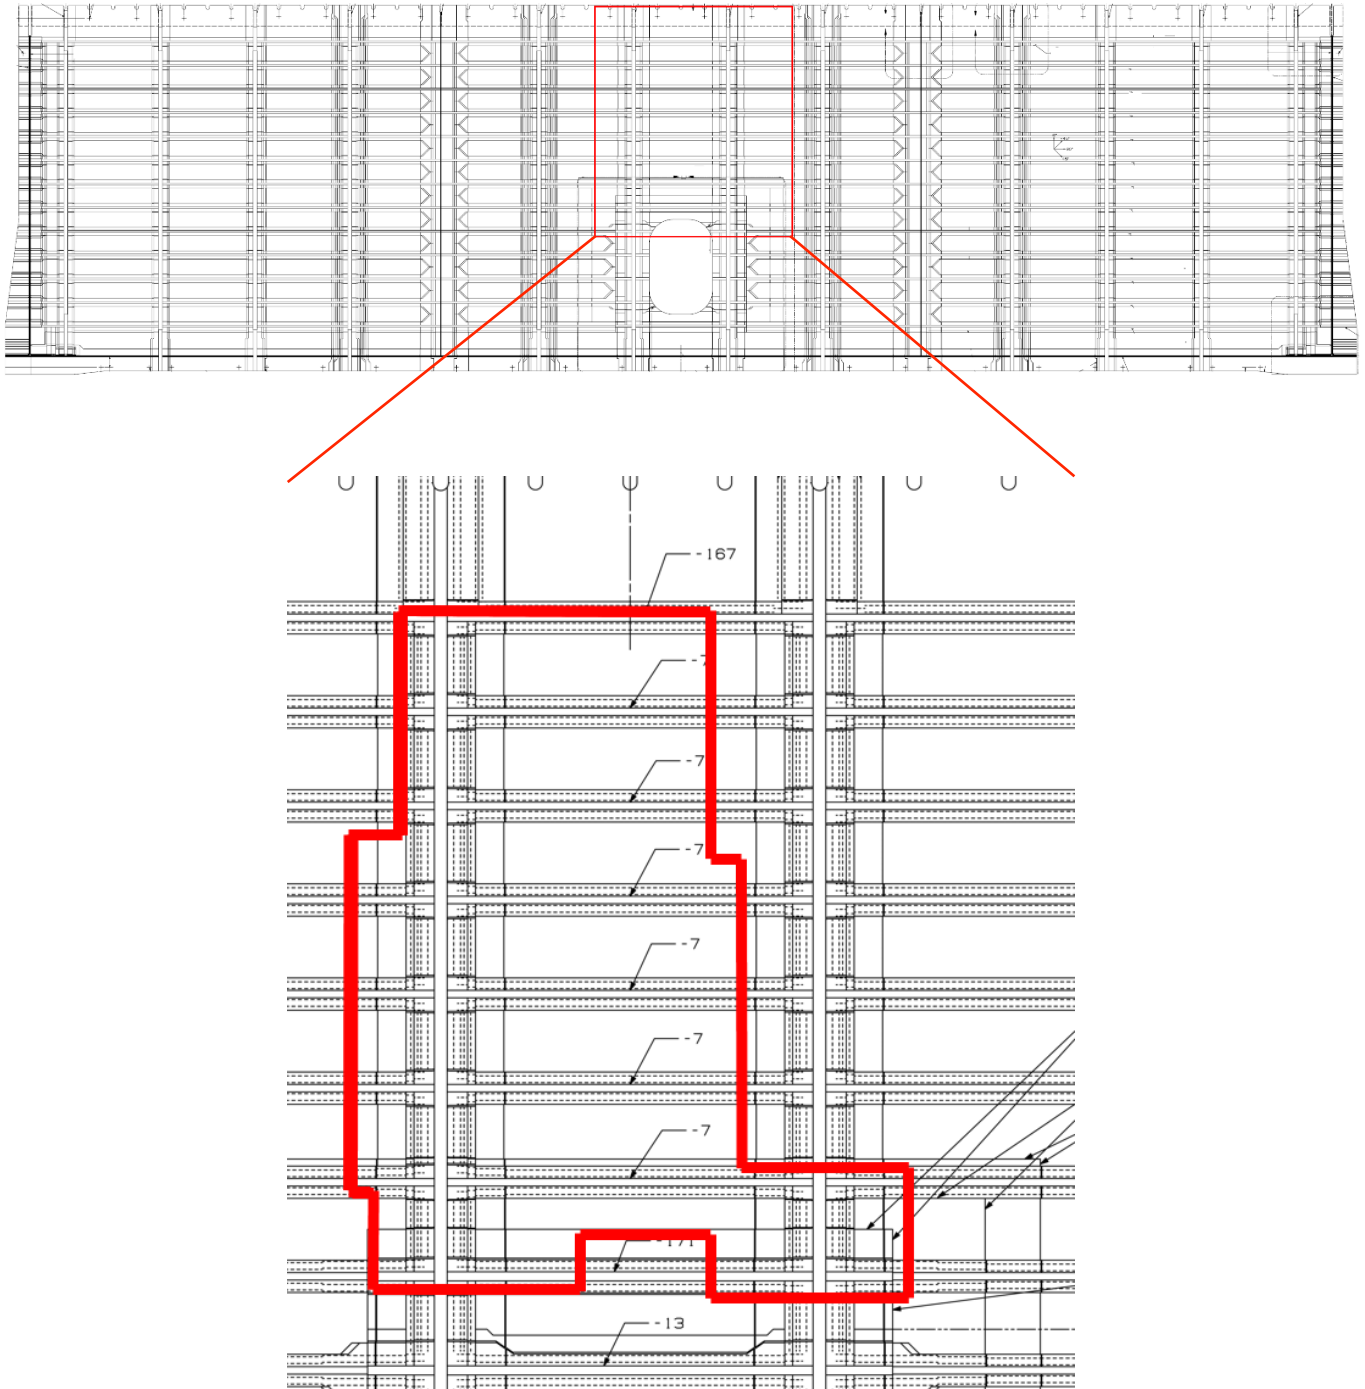
FIGURE 37. The location of the six forward bulkhead scans

Six overlapping ultrasonic scans of the forward bulkhead around the visible cracks were performed. The location and outline of the extent of these overlapping scans on the upper bulkhead is presented in Fig. 37. Figure 38 presents a compilation of the delaminations detected in this area.

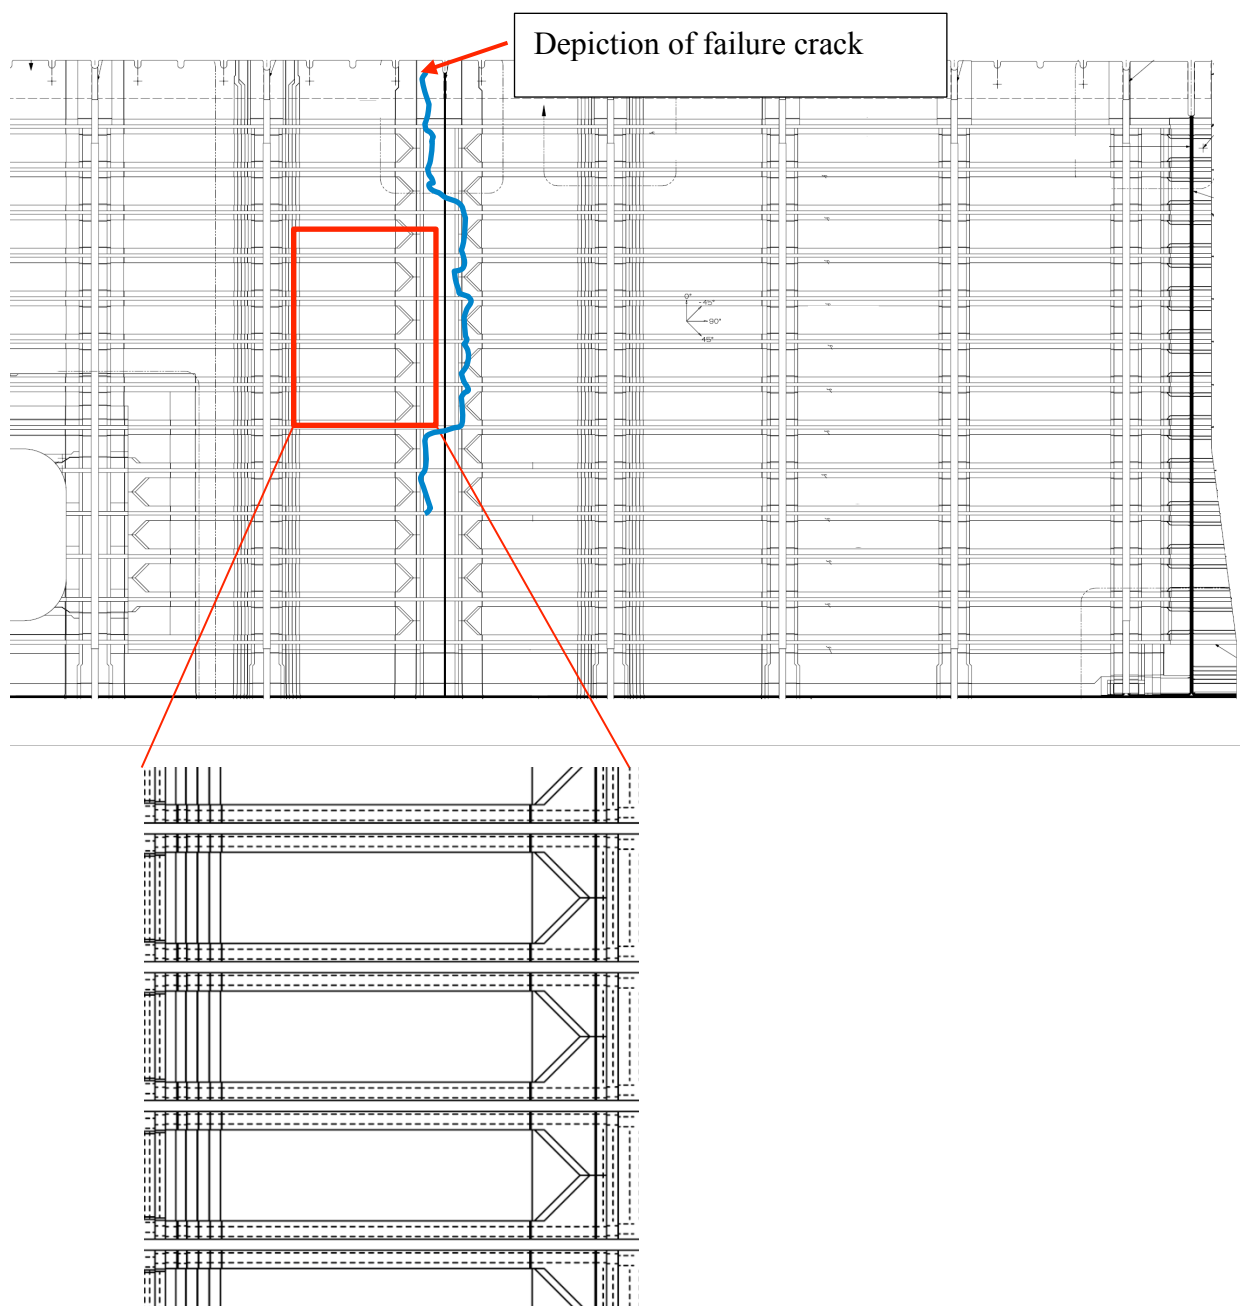
FIGURE 46. Location of the aft bulkhead failure crack in relation to the structure geometry.

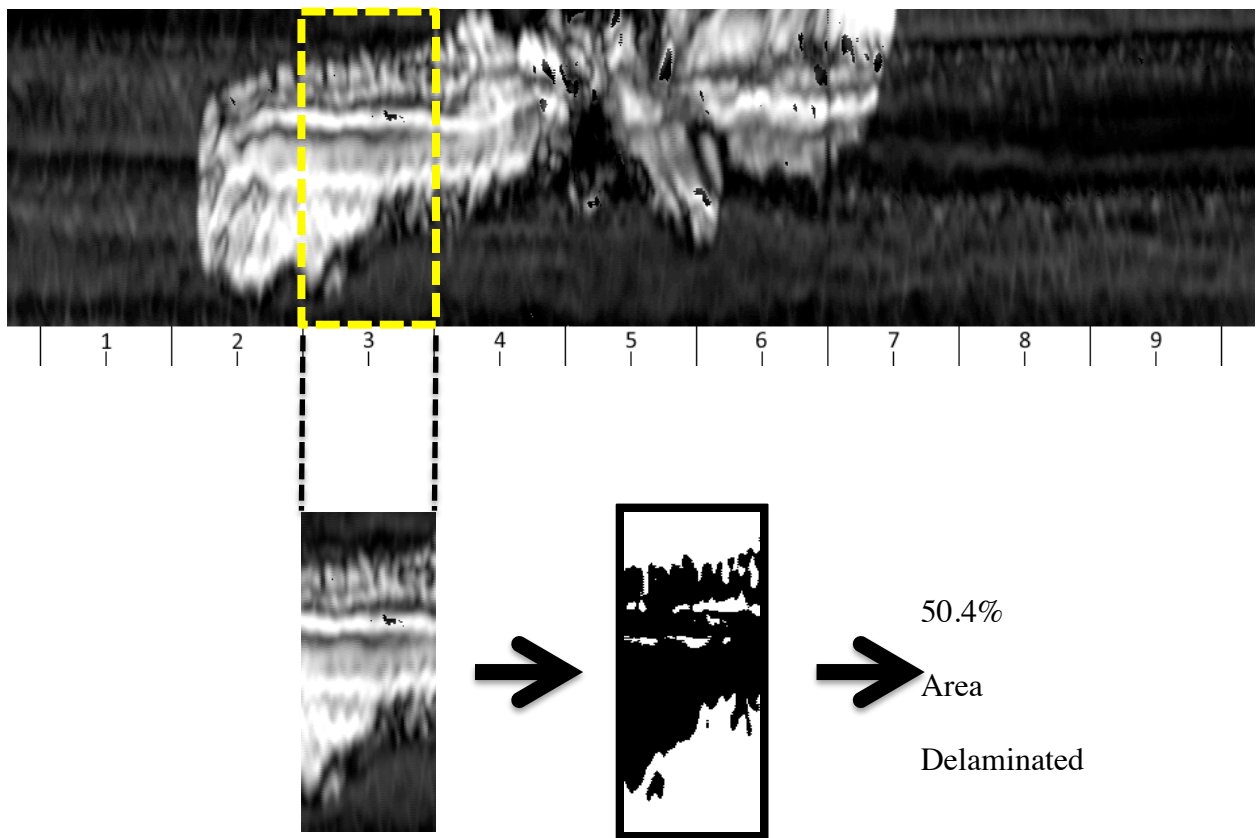
The C-scan images were segmented into nine 1-inch wide areas, corresponding to the 1-inch long push-out specimens which were to be cut from the larger rod (Fig. 51). The fraction of the

area occupied by signals arising from delamination was measured, to serve as an index of the severity of damage. The results for the eight 9-inch long specimens are tabulated in Table 2.

FIGURE 51. Example of the calculation of fractional area of delamination in a push-out specimen.
